CASE STUDY

HYDRO TECH

Lignum Vitae Seals

Horizontal Turbine

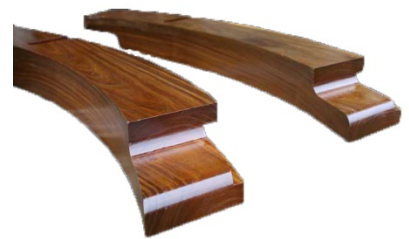
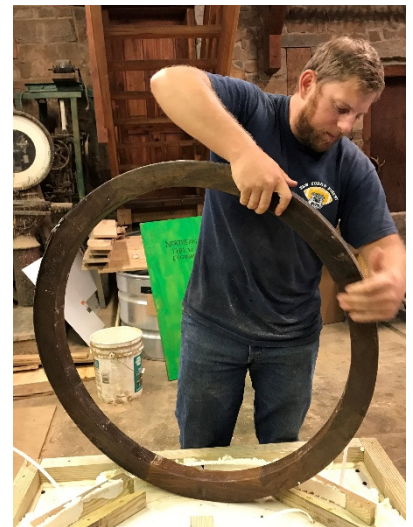
- Modified/improved design of eight (8) lignum vitae segment brass-backed replacement bearings and 350 BHN polished thrust ring that fit within bearing existing housing
- Lignum vitae material outperformed OEM composite seals under same load conditions
- Withstood trials with more than 20 stop-starts and 1,400 hours of uninterrupted operation
- Less than .08" break-in wear
- Slight modifications improved water flow and flow direction
