CASE STUDY

SS JEREMIAH O'BRIEN

Lignum vitae stave bearings

Class EC-S-CI (Liberty Ship)
Launched June 19, 1943

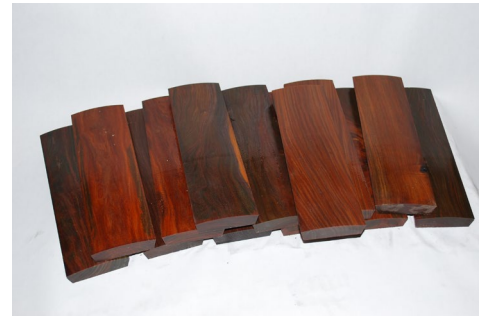
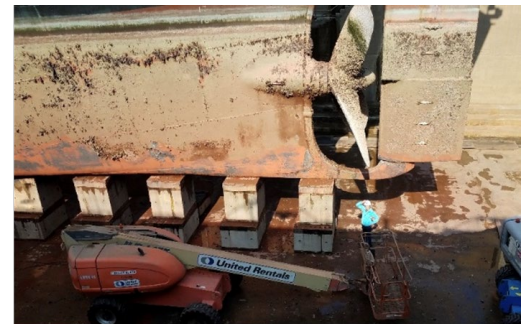
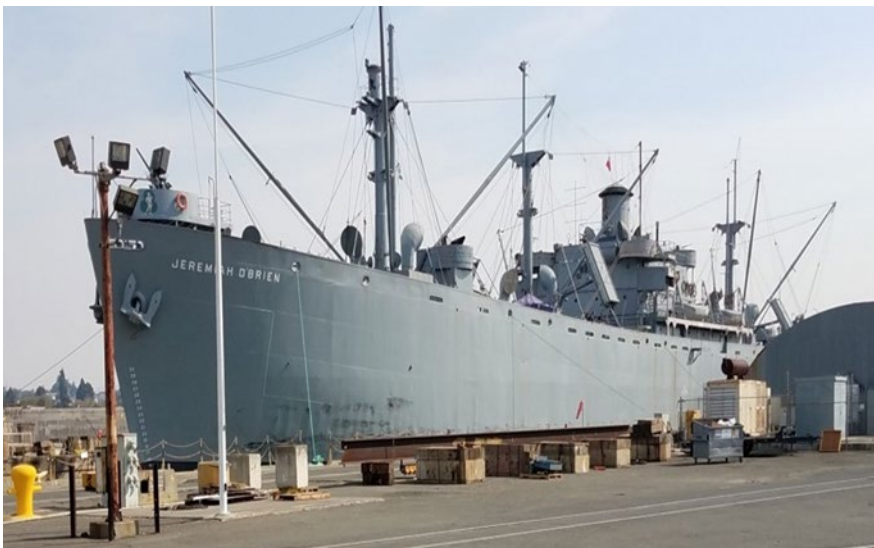
After 74 years of wear the rudder clearance exceeded standards and needed to be replaced. 13 rudder bearing staves 3" w x 10" long mostly 9/16" thick held in place by vertical bronze keepers and one key stave. Top staves saw very little wear. Staves had to be varying thicknesses because at time of repair rudder was offset from center.

Replace original rudder bearing with lignum vitae, the original rudder bearing material. Composite material was considered but was more expensive with longer lead time for delivery and installation and did not have the performance history of lignum vitae. The new lignum vitae bearing will be used to bring the rudder back into alignment.

The rudder bearing replacement took fewer than two weeks out of the six-week yard period. Lignum Vitae North America and repair team was solutions focused, so problems that did arise were handled promptly. The lignum vitae bearing staves took approximately one day to install and the installation went smoothly. To date the solution is performing perfectly - no rocking, no sticking, moves freely.
